**(CAVITATION DAMAGE OF MECHANICAL  
PUMP IMPELLERS OPERATING IN  
LIQUID METAL SPACE POWER LOOPS)**

CAVITATION DAMAGE OF MECHANICAL PUMP IMPELLERS  
OPERATING IN LIQUID METAL SPACE POWER LOOPS

By R. S. Kulp and J. V. Altieri

Prepared under Contract No. NAS 3-2541 by  
PRATT & WHITNEY AIRCRAFT DIVISION  
UNITED AIRCRAFT CORPORATION  
CANEL - Middletown, Conn.

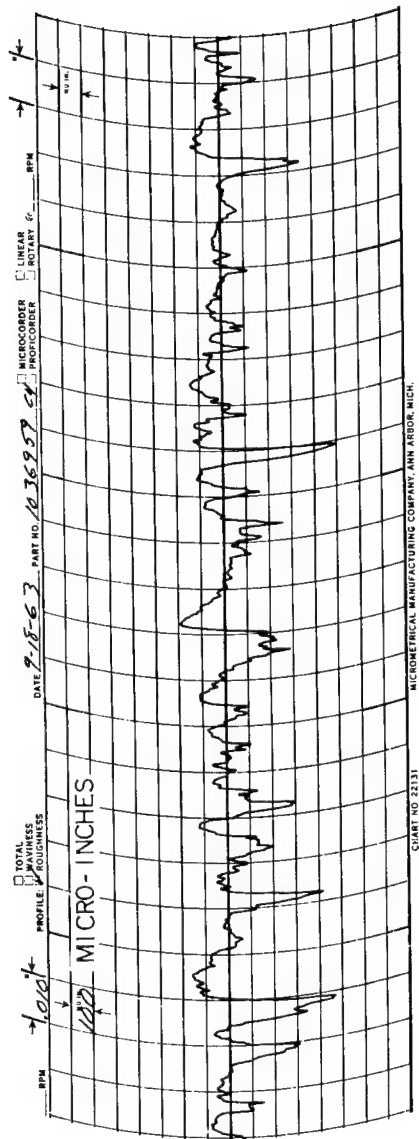
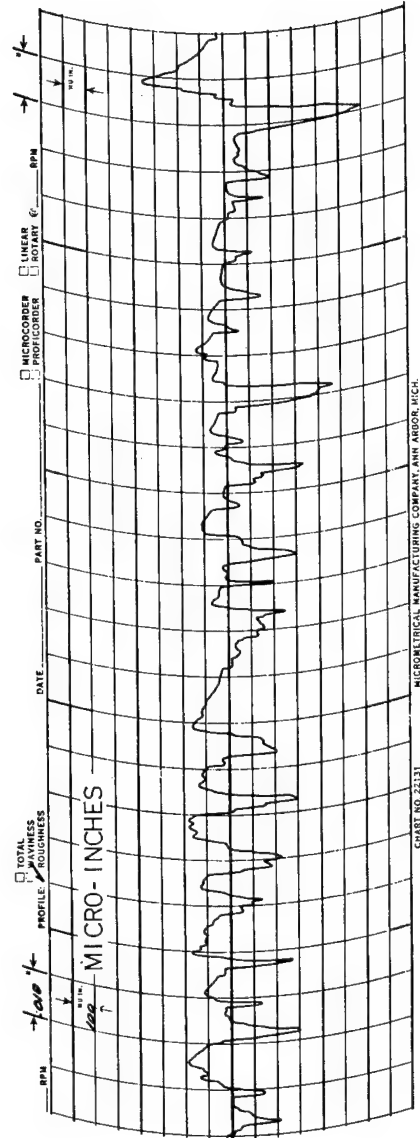
# SURFACE ROUGHNESS MEASUREMENTS COMPARED AFTER WATER TEST BLADE 2, STATION 6, PRESSURE SIDE

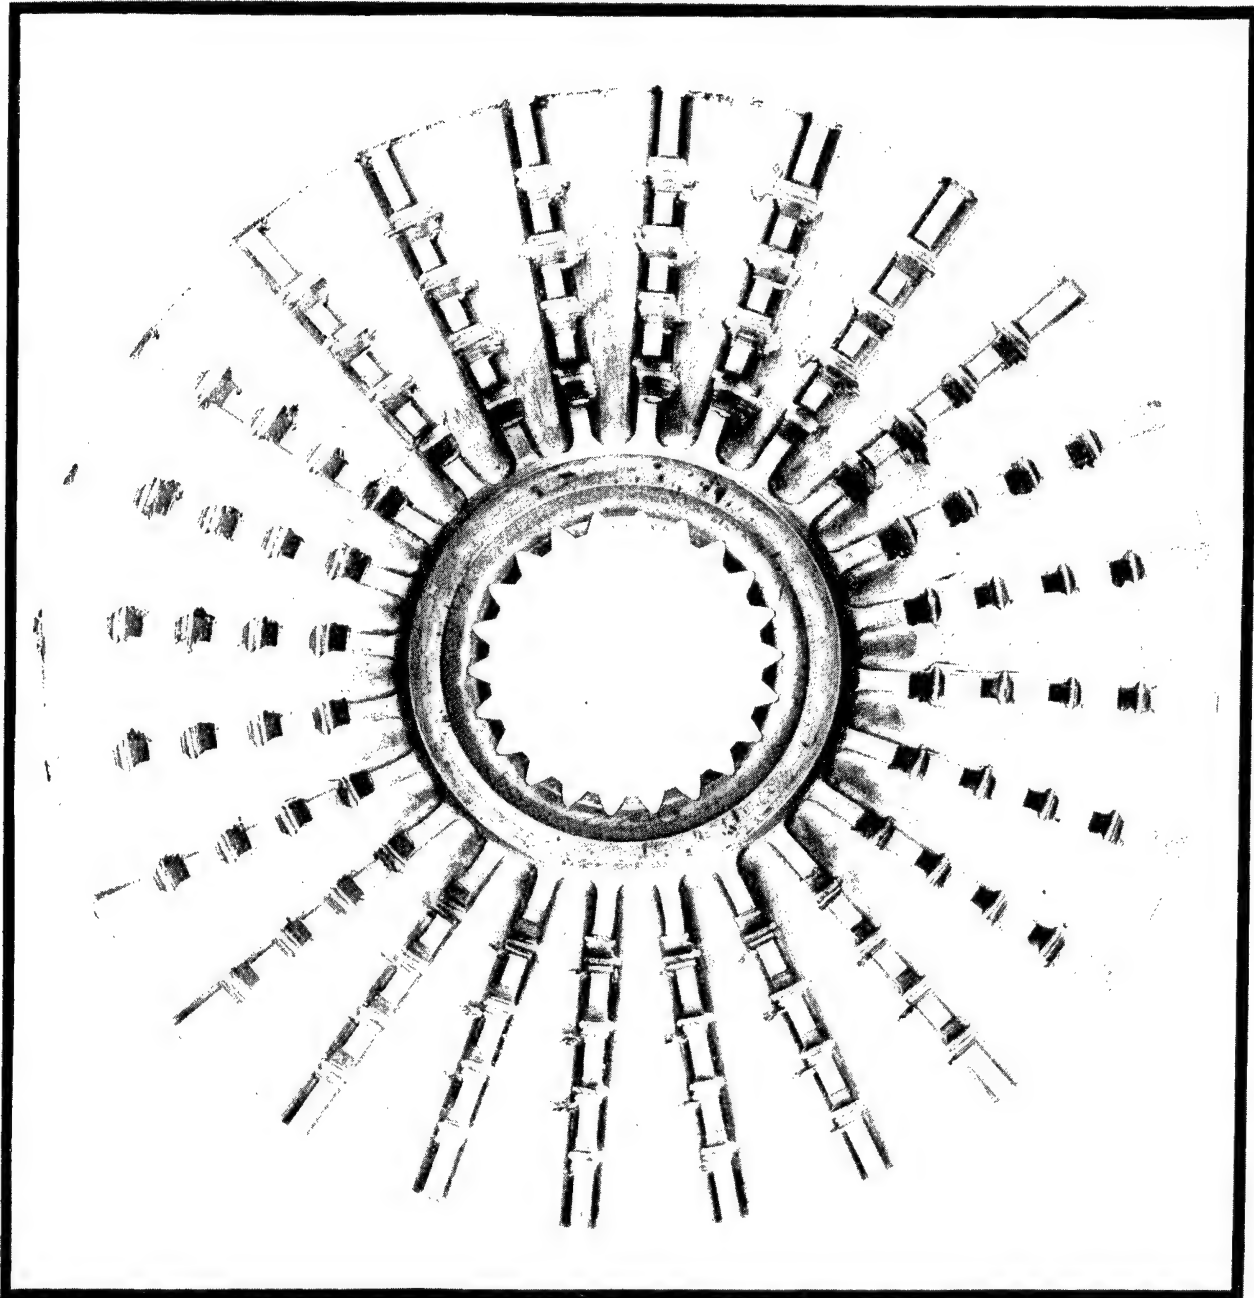
FIG 52

Complete disassembly of the pump revealed additional rubbing damage of the rotating parts. The damage on the impeller is shown more clearly in Fig. 50. It should be noted that the damage is not uniform around the impeller. Very little material was injected into the fluid stream, as evidenced by the apparent flow of metal at the blade tips. Scroll damage from contacting the impeller is shown in Fig. 51. Again, the unsymmetrical pattern of damage should be noted. The cause of the rubbing contact cannot be fully determined from the evidence uncovered, due to the difficulty of separating cause and effect relationships of the damage. However, the unsymmetrical pattern of damage leads to a tentative conclusion that the shaft moved to one side during operation. This is further confirmed by the rubbing damage noted on the dynamic seals shown in Figs. 52 and 53. The cause of this apparent shaft movement has not been satisfactorily determined.

LOWER DYNAMIC SEAL (POSTTEST)

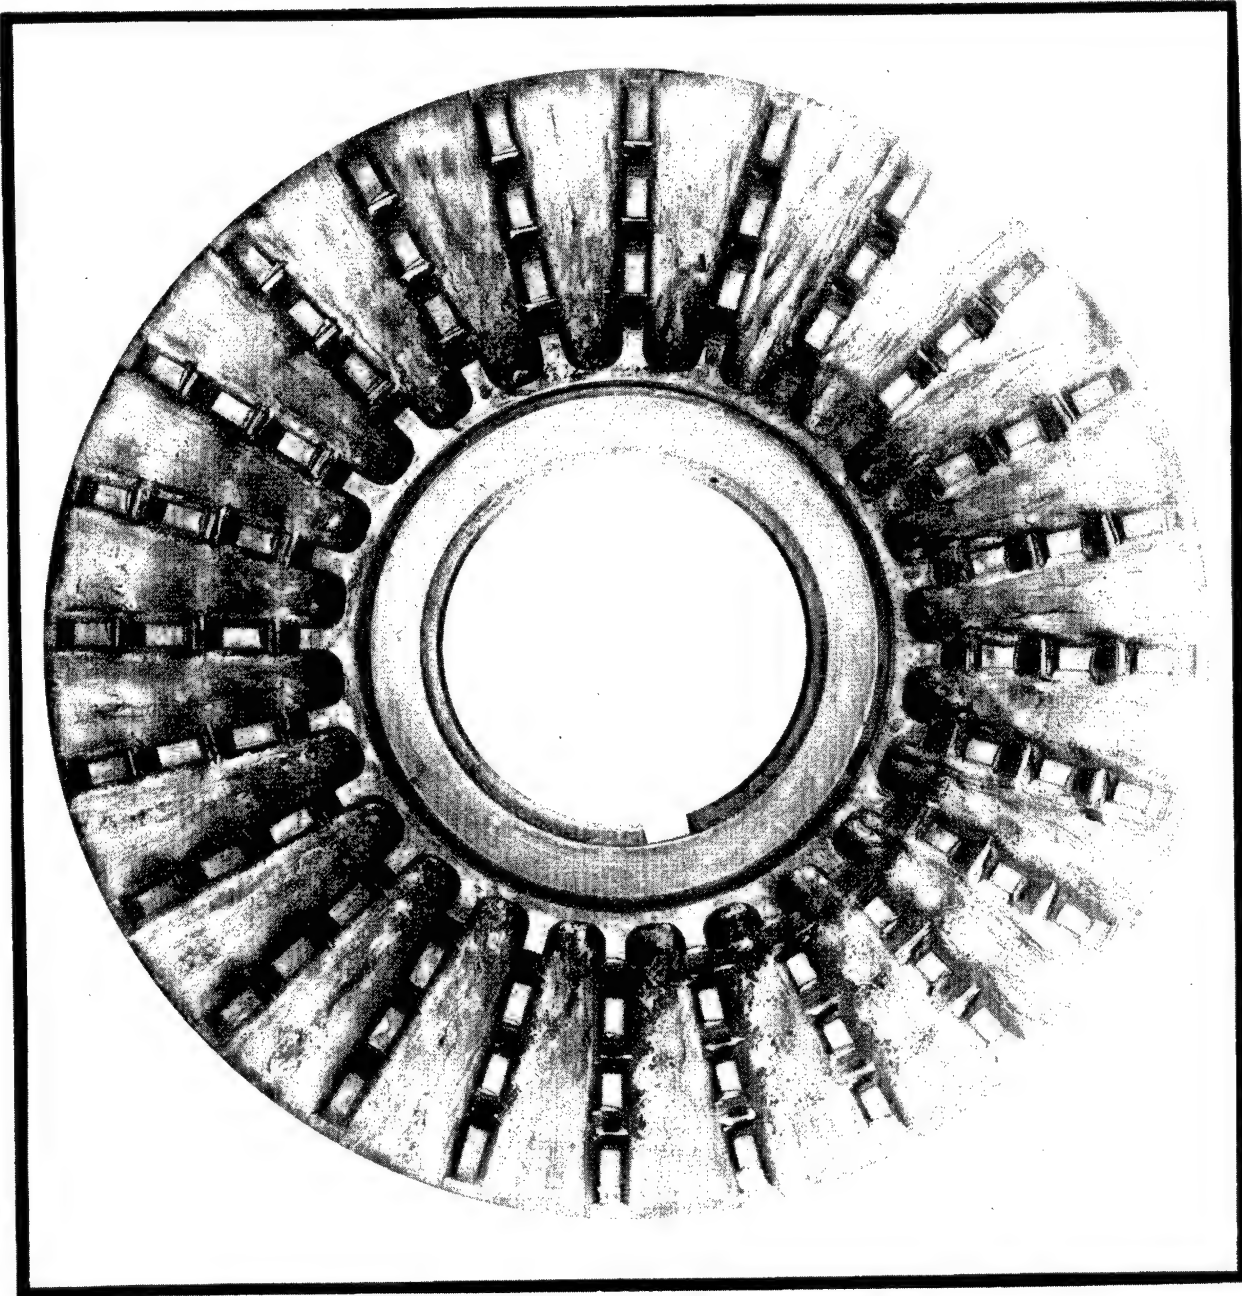
FIG 53

UPPER DYNAMIC SEAL (POSTTEST)

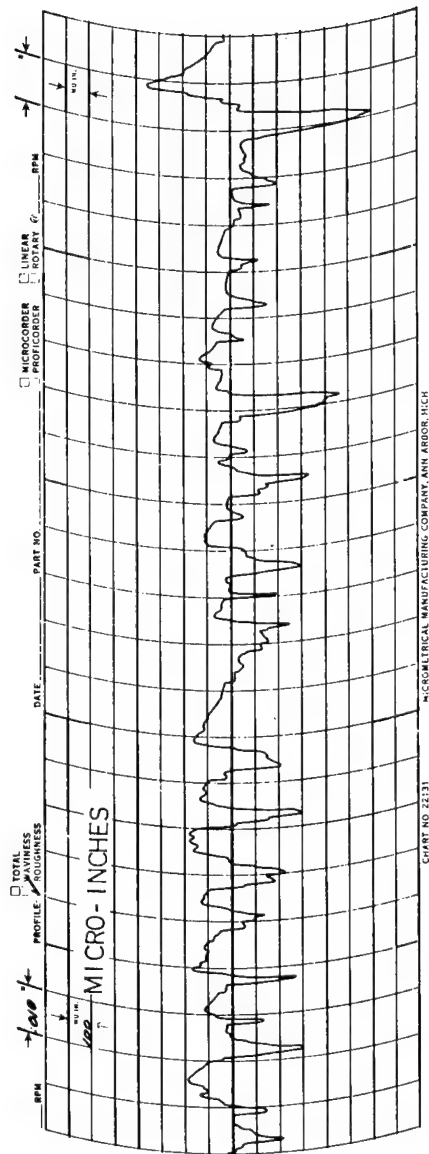
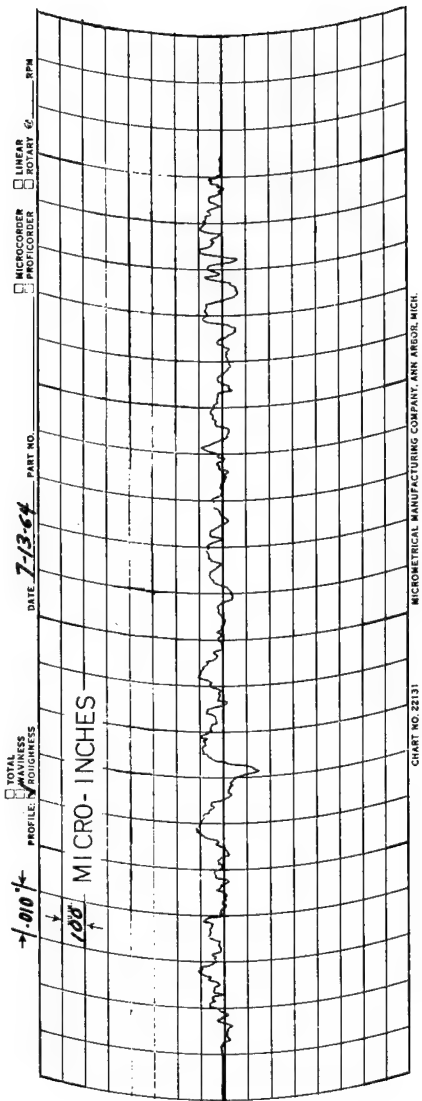
FIG 58

A complete program of inspection was performed on the impeller using all techniques previously noted. The surface roughness measurements made along the same vane stations as those in pretest indicated a slight smoothening of the surface had occurred. This can be seen in the surface roughness traces shown in Fig. 58. This smoothening action was apparently caused by a slight erosive action of the liquid metal.

SURFACE ROUGHNESS MEASUREMENTS COMPARED AFTER  
LIQUID METAL TEST  
BLADE 2, STATION 6, PRESSURE SIDE

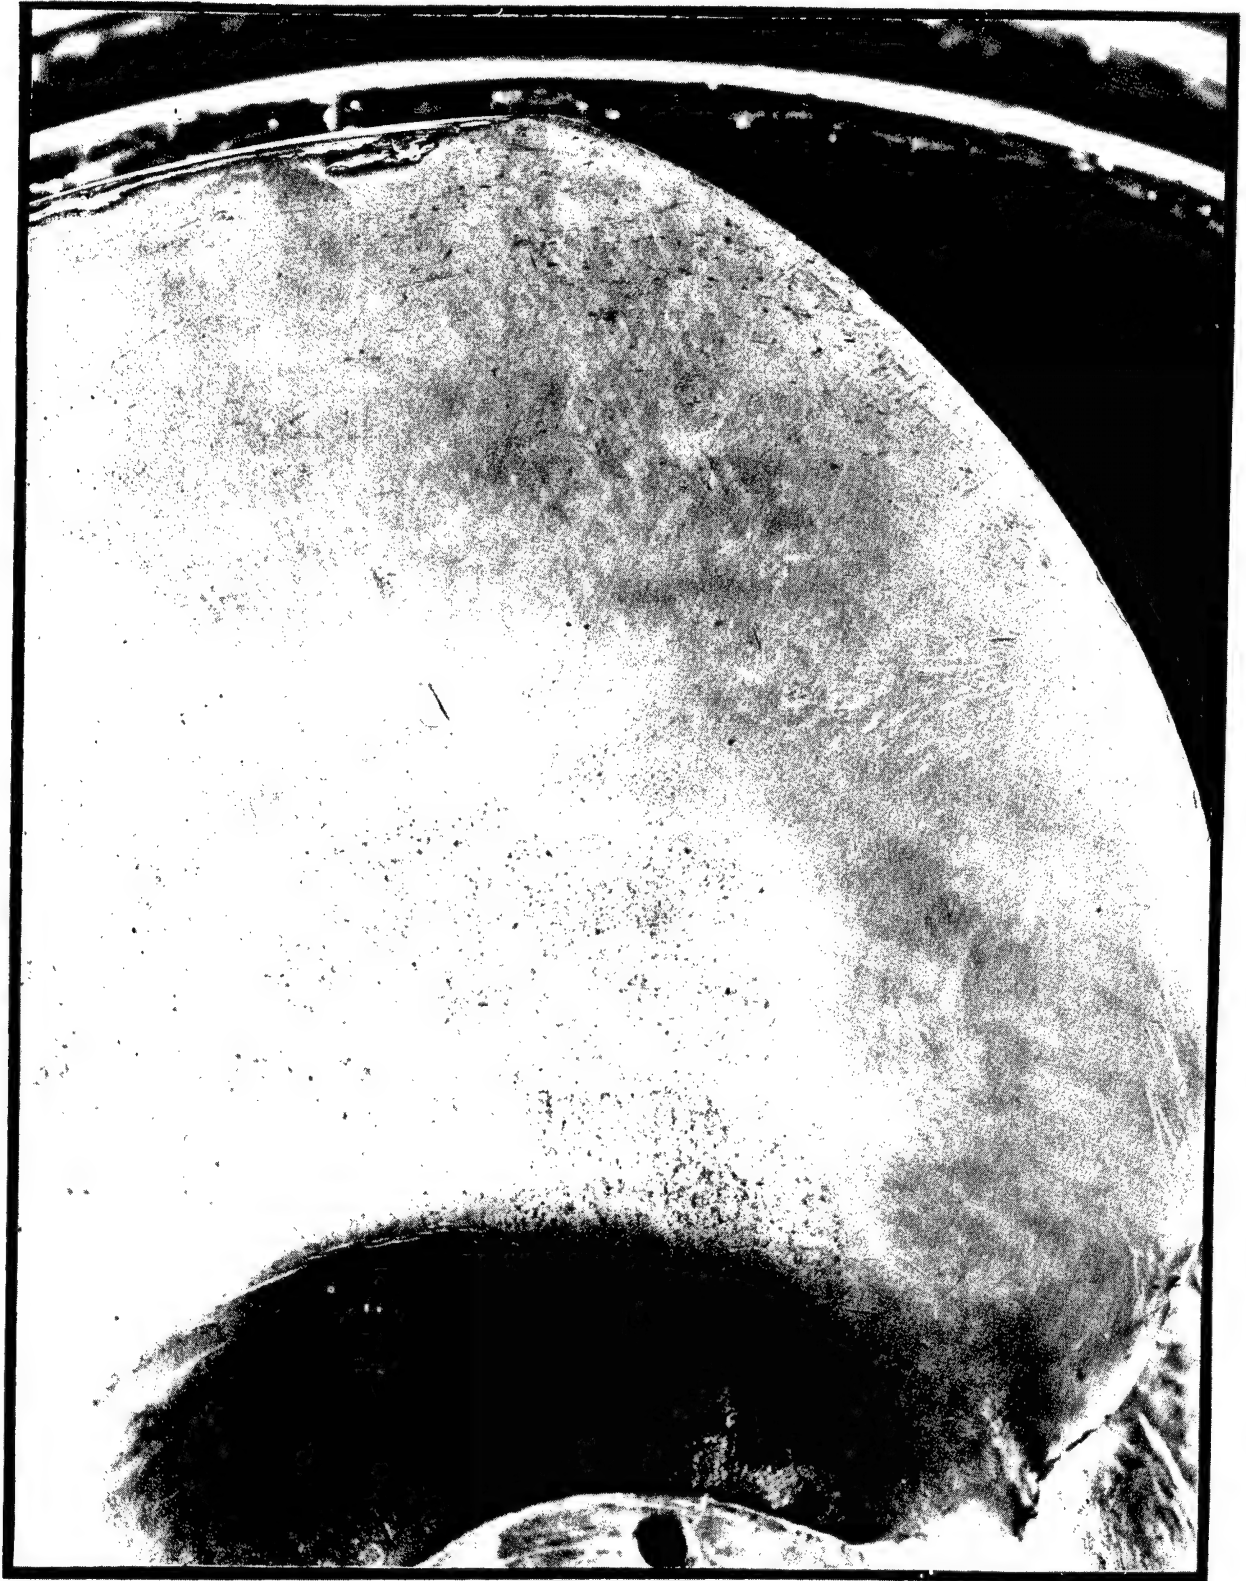
FIG 62

Photographic enlargements were also made of the inlet suction surfaces. A typical photograph is shown in Fig. 62. These photographs were taken at enlargements of two times and four times size and have the potential of enlargement to 20 times size.

POSTTEST VIEW OF RI-7C3 IMPELLER VANE 2 SURFACE

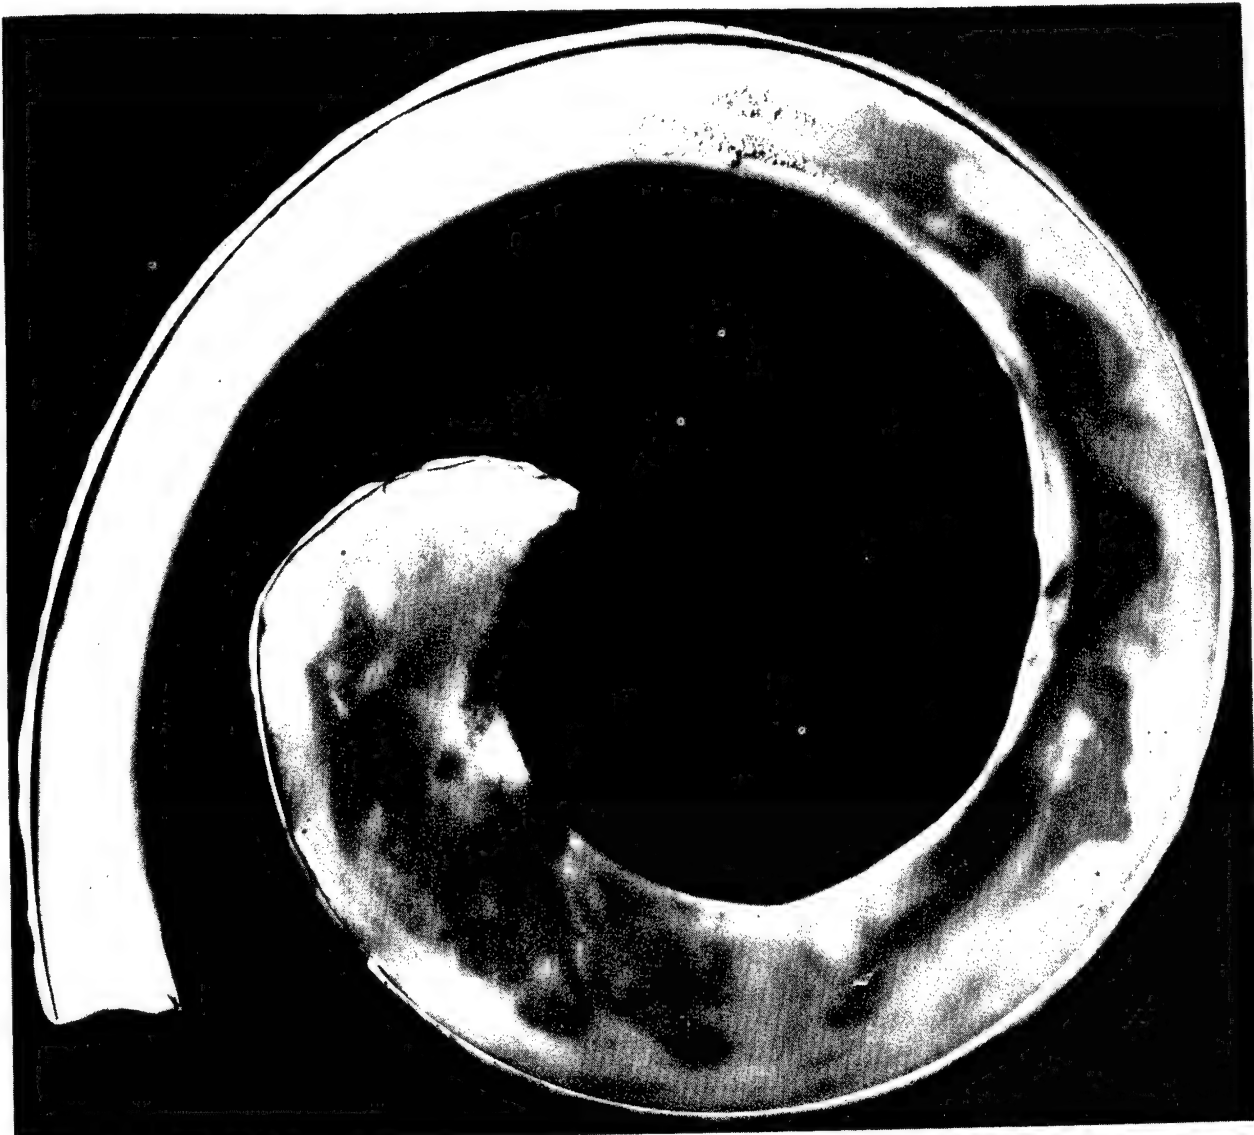
FIG 63

A typical rubber mold is shown in Fig. 63 of the entire pressure surface of vane 2. Fig. 63A is the heavy cavitation damage area of vane 2 photographed at 11X with the mold laid over a sharp edge. Fig. 63B is the rear channel damage of vane 1, photographed by the same technique but at higher magnification (23X). The partial translucence of the rubber material does not allow surface features to stand out in sharp contrast when looking directly at the surface, even under high magnification. The best method of interpreting the rubber molds appears to be the technique employed in photographing.

RUBBER MOLD OF IMPELLER VANE SURFACE AFTER POTASSIUM TEST  
PRESSURE SURFACE OF VANE 2

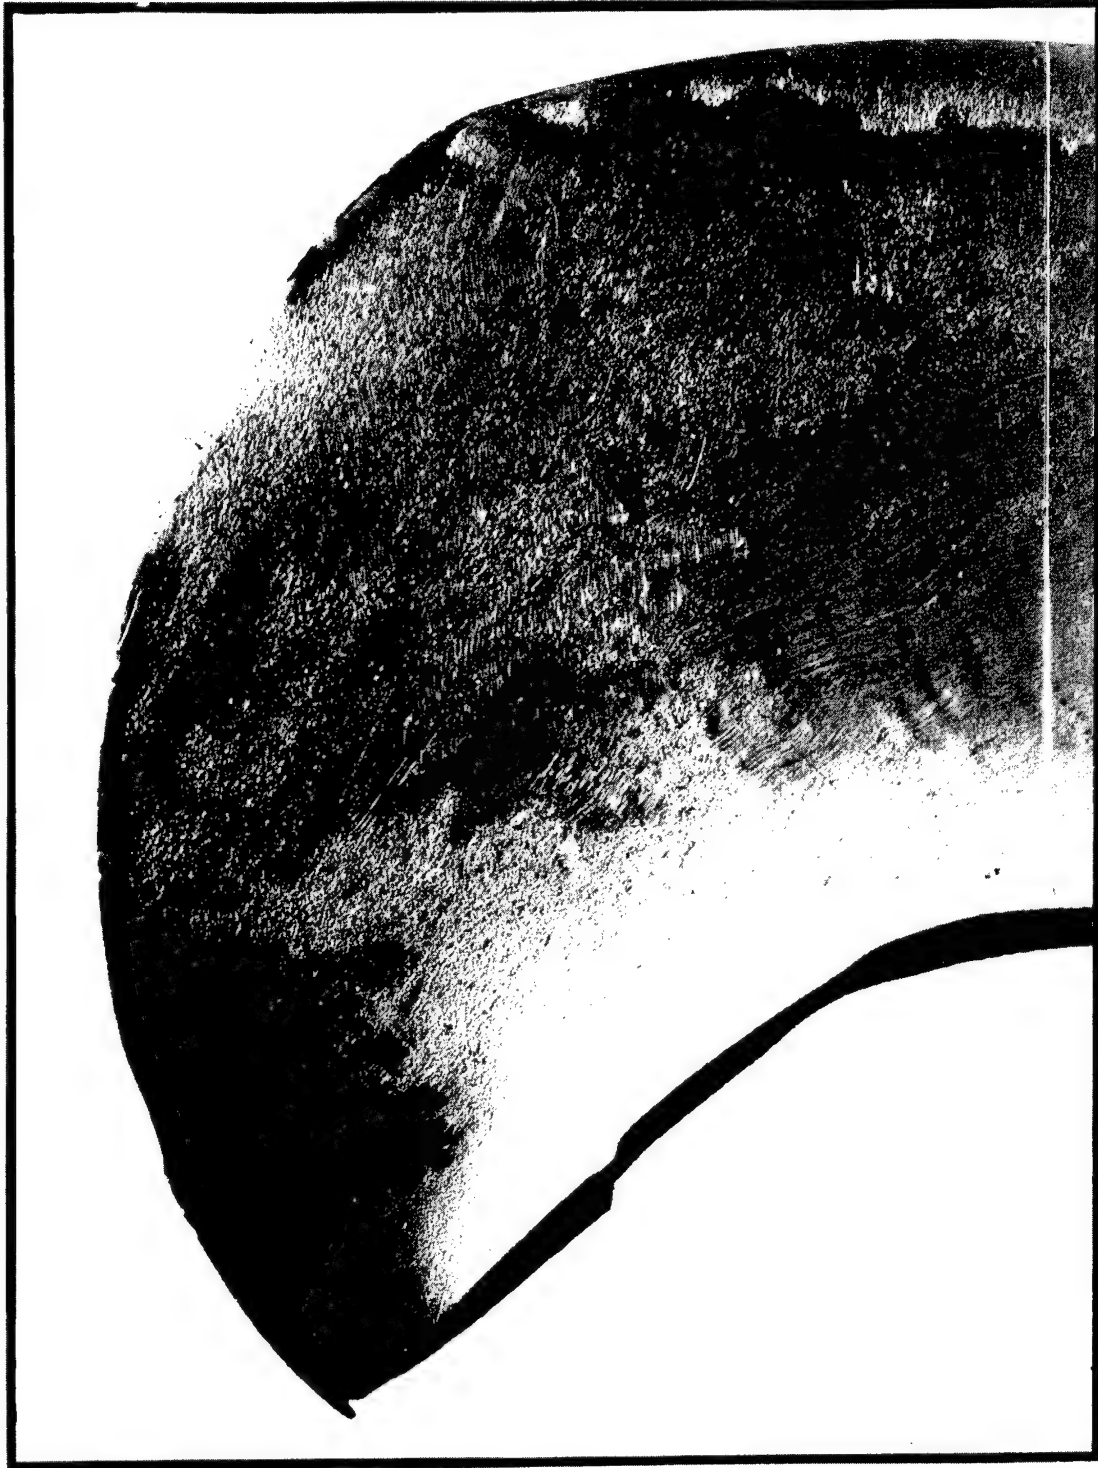
FIG 64

Vane 3 was cut from the inlet of the impeller in order to inspect the pressure surface in more detail. A section of this vane is shown at 3 1/2 magnification in Fig. 64. Small single pits are apparent on the surface in this photograph. These pits are shown at 23 magnification in Fig. 65. A count of pits of all sizes in Fig. 65 shows approximately 30 pits per square inch. A similar examination of pits on the suction surface of the vane showed only two pits per square inch, all occurring within the impeller flow channel. Examination of the area of the impeller vane suction surface as seen when looking directly into the inlet revealed no cavitation pits.

PRESSURE SIDE OF VANE 3 REMOVED FROM IMPELLER

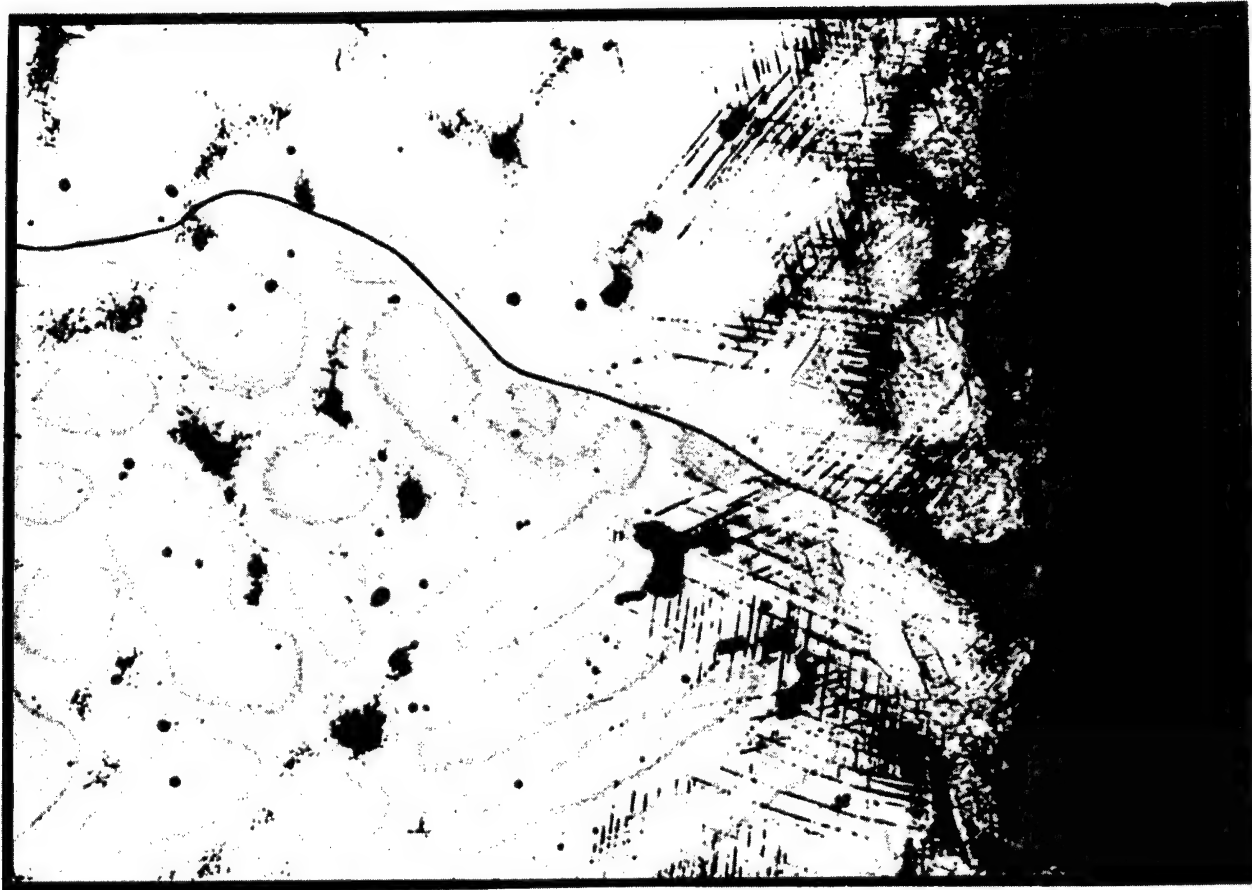
FIG 68

Metallographic examination of the cavitation damage areas in the impeller rear channels was done in an attempt to determine a mechanism of damage. This examination failed to show conclusively any mechanism by which cavitation damage propagates. A microsection of the "as cast" structure is shown in Fig. 68. This figure shows the typical large grain cored microstructure normally associated with cast type 316 stainless steel. Widmanstatten carbide precipitation observable in this figure is typical of all surfaces and results from the casting process. A microsection of post-test material undamaged by cavitation is shown in Fig. 69. The time and temperature effects are noted in the more homogeneous dispersion of the carbide phase throughout the matrix. The light band along the surface is shown at higher magnification in Fig. 70. This band shows a tendency toward recrystallization to extremely small grains with spheroidal carbide precipitation at the grain boundaries. This effect was noted in microsections of deep cavitation damage to exist on all surfaces exposed to the liquid metal.

## PHOTOMICROGRAPH OF PRETEST MATERIAL

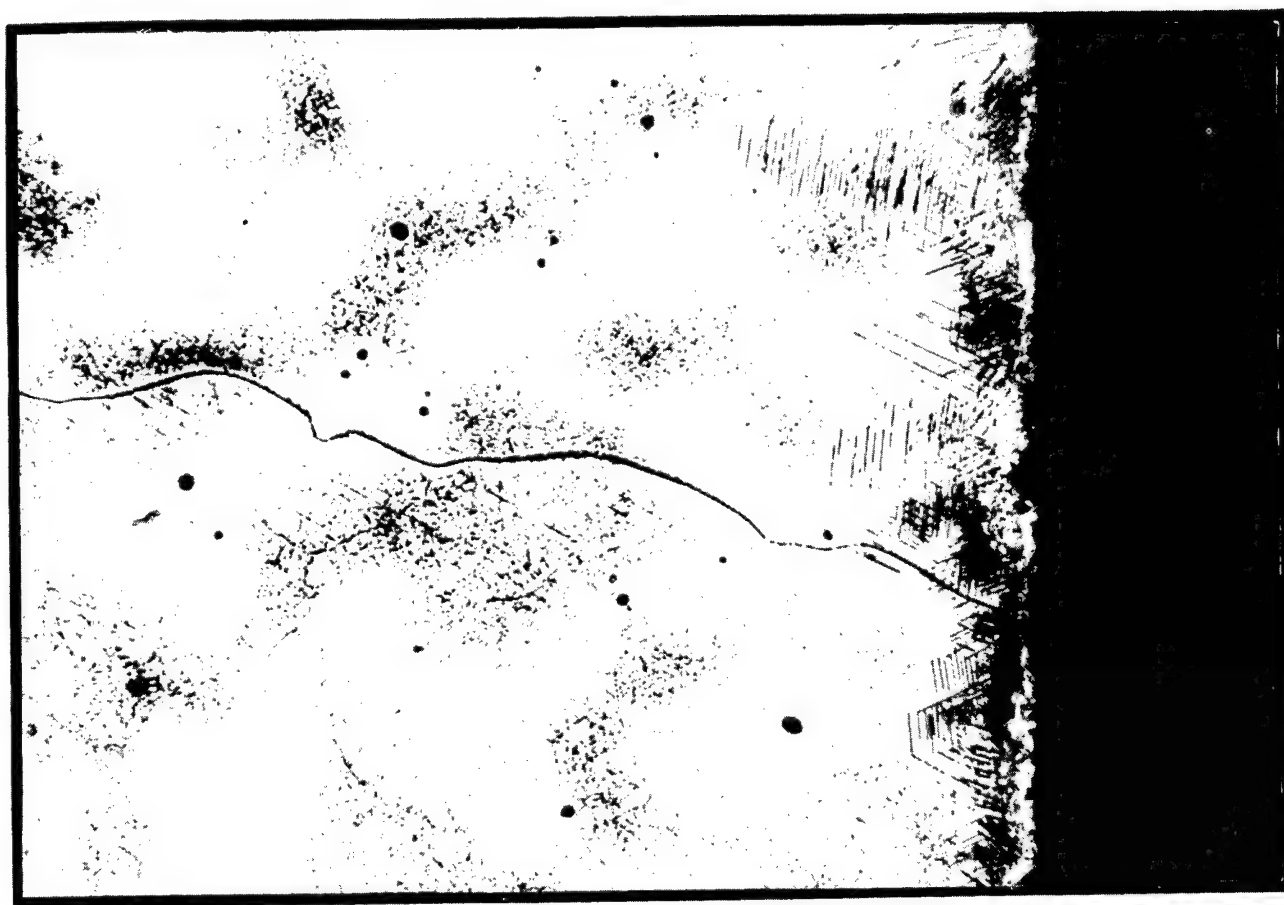
FIG 69

# PHOTOMICROGRAPH OF POSTTEST UNDAMAGED MATERIAL

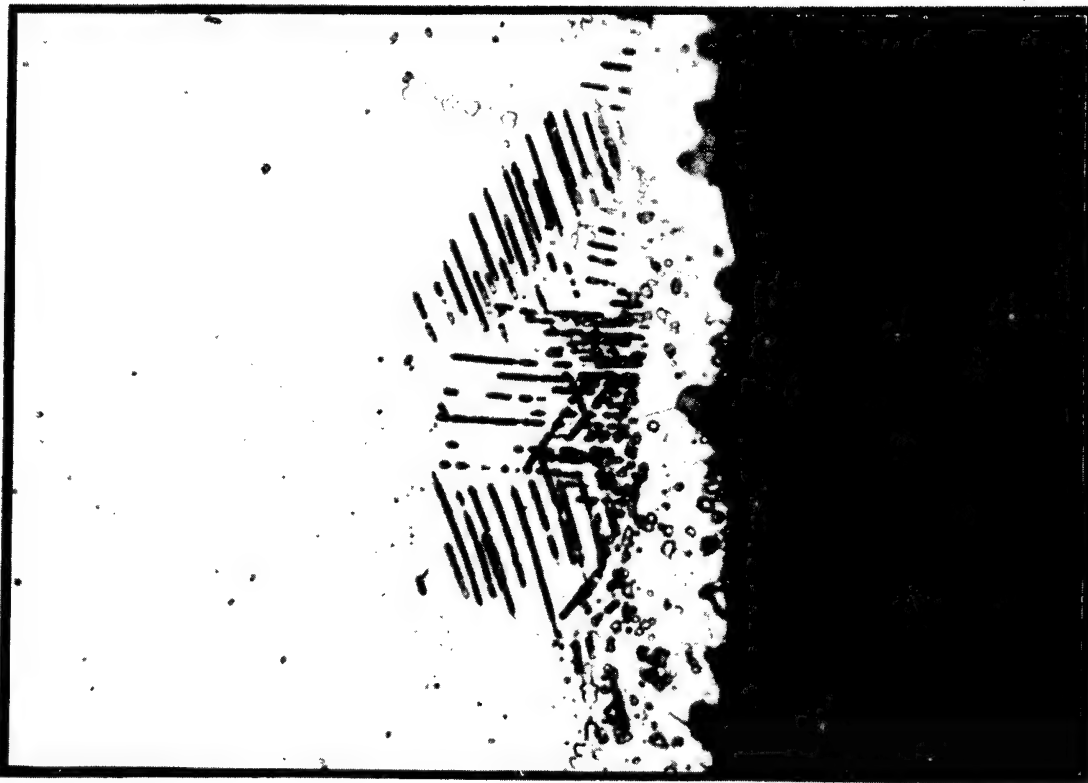
FIG 70

PHOTOMICROGRAPH OF POSTTEST MATERIAL OF FIG. 69 AT HIGHER  
MAGNIFICATION
